## SOME LOCAL EFFECTS OF THE SAN FRANCISCO EARTHQUAKE

STEPHEN TABER  
Leland Stanford Junior University

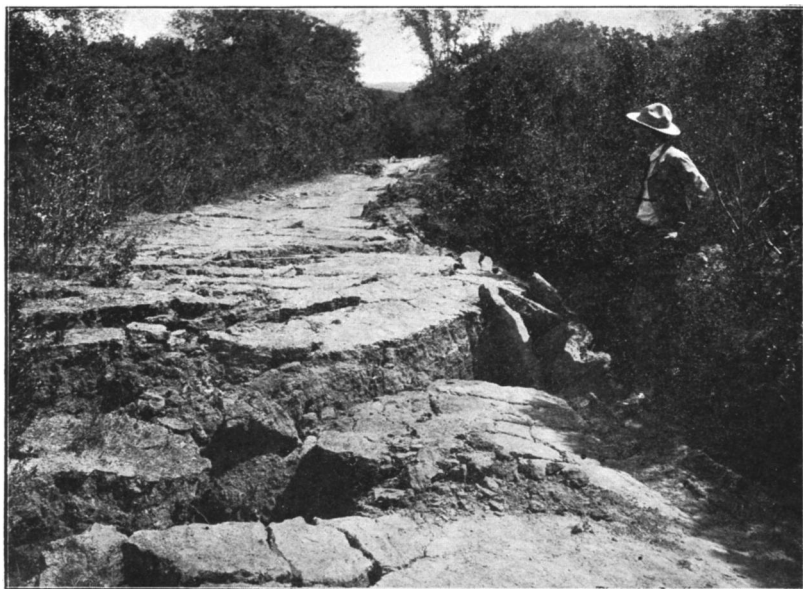
lateral displacement is well defined, as far as it has been traced, and at some points amounts to as much as 9 feet. The vertical displacement in most places is not so evident, but about a mile southeast of Portola there is an uplift of 2 feet on the northeast side, and the same amount of vertical displacement has been observed on Black Mountain.

FIG. 3.—Road crossing the fault-line two miles southeast of Portola. There is a vertical uplift on the northeast side of the fracture at this place.

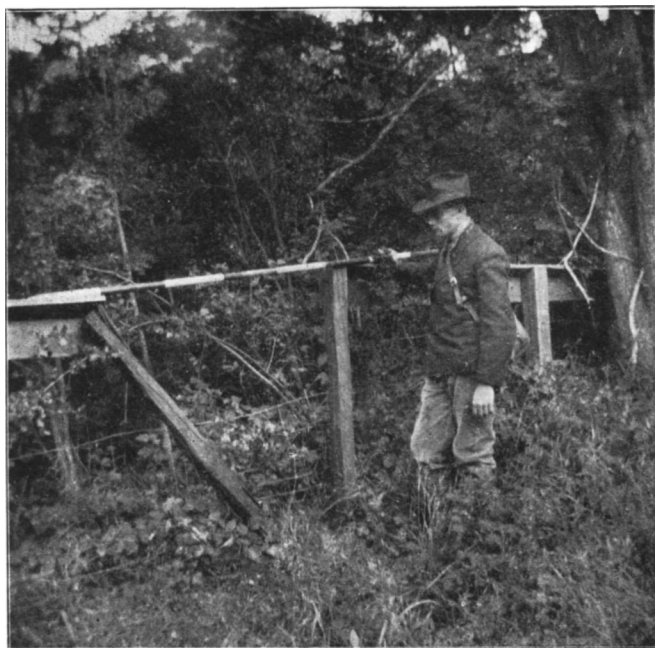
FIG. 4.—Showing a fence that crossed the fault at an oblique angle. The post shown in the photograph was split and pulled apart and the wires broken.

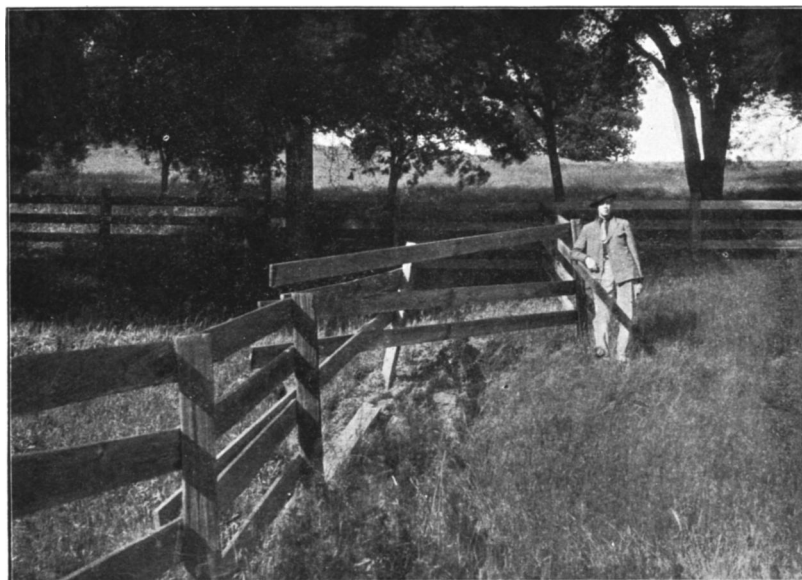
FIG. 5.—Showing a fence that was broken and offset eight feet where it crossed the fracture.

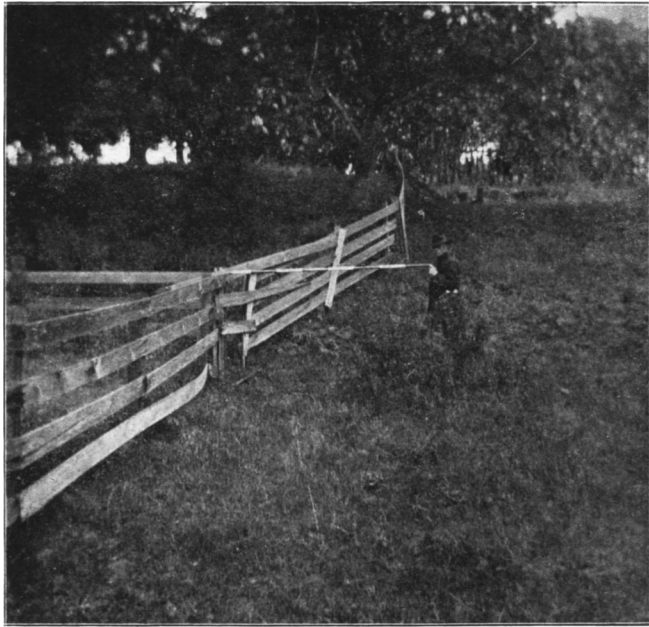
The photograph (Fig. 6) shows a line fence crossing the fault

a mile southeast of Woodside. This fence was broken and displaced over 8 feet, but had been repaired before the photograph was taken. The man at the right in the picture is holding an 8-foot transit rod, and he is standing in line with the continuation of the fence on the far side of the fracture. The crack crosses the fence just back of where he is standing.

FIG. 6.—Photograph of a fence crossing the fault-line at right angles. The man is holding an eight-foot transit rod and stands in line with continuation of the fence on the far side of the fracture. The fence was repaired before the photograph was taken.

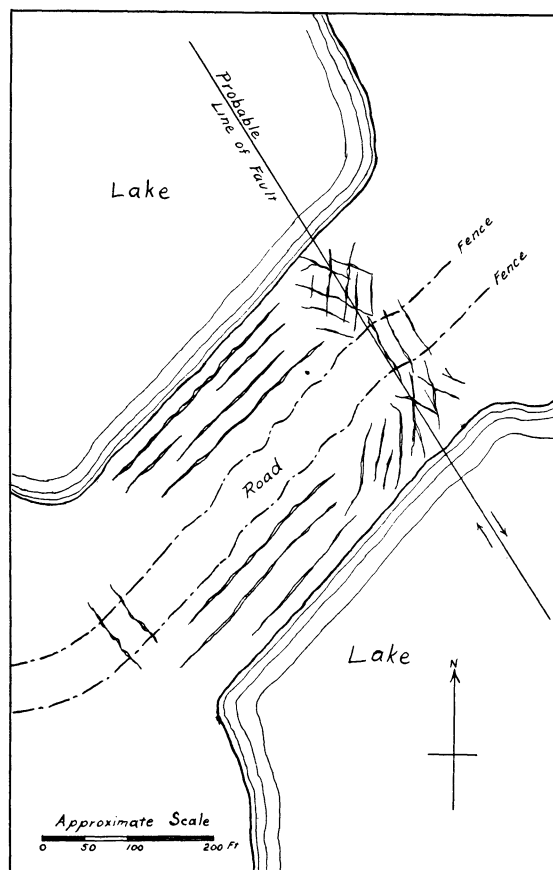
FIG. 7.

A striking evidence of displacement is shown in the earth dam that divides the Crystal Springs Lake. This dam is about 500 feet

in length, and the road from San Mateo to Half Moon Bay runs along its crest. The accompanying sketch (Fig. 7) shows the position and direction of the cracks that were formed in the dam. The larger cracks are about 6 inches wide and are parallel with the dam. Smaller intersecting cracks were formed near the northeast end of the dam along the probable line of the fault, and the road was offset about 6 feet at this point. The fences on both sides of the

road were broken in a number of places, and the unbroken boards were bent and arched so as to give a serpentine appearance to the fences. The wires of a telephone line crossing the dam sag in great loops.

*Dam at Crystal Springs Lake  
showing cracks formed by the displacement.*

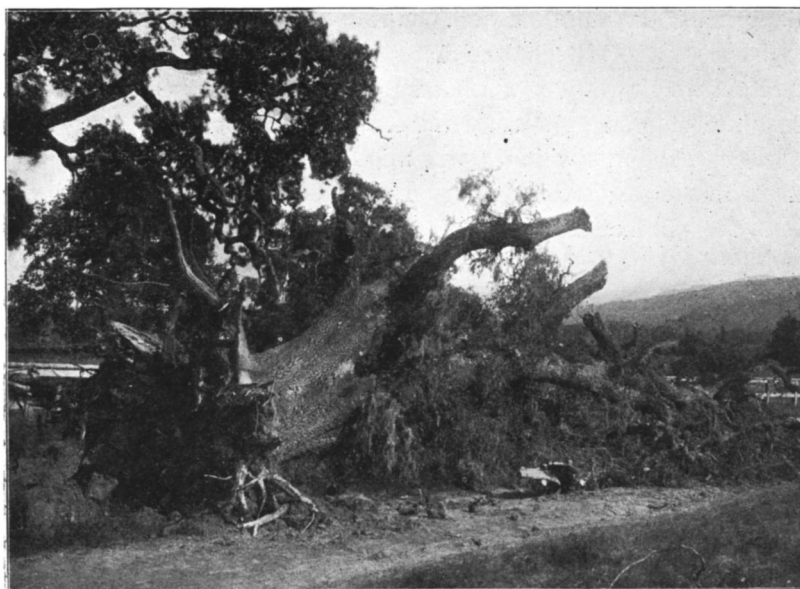
FIG. 8.—An oak tree six feet in diameter uprooted by the earthquake three hundred yards from the fault line.

for not more than 400 or 500 yards on each side of the fracture many of these trees have been uprooted or have had large branches whipped off. Sound limbs 2 feet thick were broken off by the shock, and there are trees having a diameter of more than 6 feet that were overturned during the earthquake. About 300 yards southwest of Searsville Lake a live oak (*Quercus agrifolia*), growing within a few feet of the fracture, was split down the trunk by the violence of the movement, but is still standing.

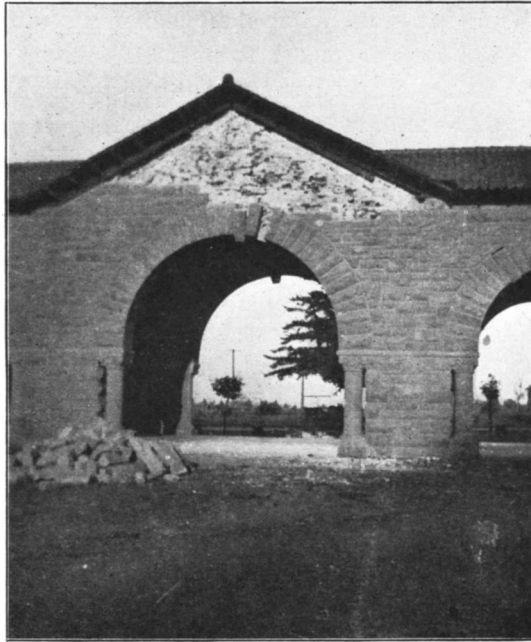
At Stanford University,  $4\frac{1}{2}$  miles northeast of the fault-line, the sandstone buildings afford evidence of the wave-motion. Walls running northwest and southeast, when free to fall, fell by toppling over, and the stones lie on the ground in nearly the same relative positions that they occupied while standing. Walls running more nearly parallel to the direction of wave-motion were crushed, and the stones fell in irregular piles, while the walls that are still standing show  $45^\circ$  shearing cracks. Perhaps the best evidence of a true wave-motion is to be found in the arches. When the crest of a wave struck an arch running northeast and southwest, the arch was pulled apart, allowing the keystones to drop a short distance. There are forty-six arches running approximately northeast and southwest in which the keystones dropped, while only twelve arches running northwest and southeast had their keystones lowered, and some of the latter may be accounted for by the falling of neighboring walls. It might be well to state that there were more arches running northwest and southeast than at right angles to that direc-

tion. Most of the keystones dropped only 5 or 6 inches, but some fell out completely.

FIG. 9.—Photograph of arches at Stanford University, showing keystones lowered during the earthquake. These arches were nearly at right angles to the fault-line.
